**Duke Energy H.F. Lee Energy Complex – Goldsboro – Wayne County**

**September 20, 2018 DEQ Site Inspection**

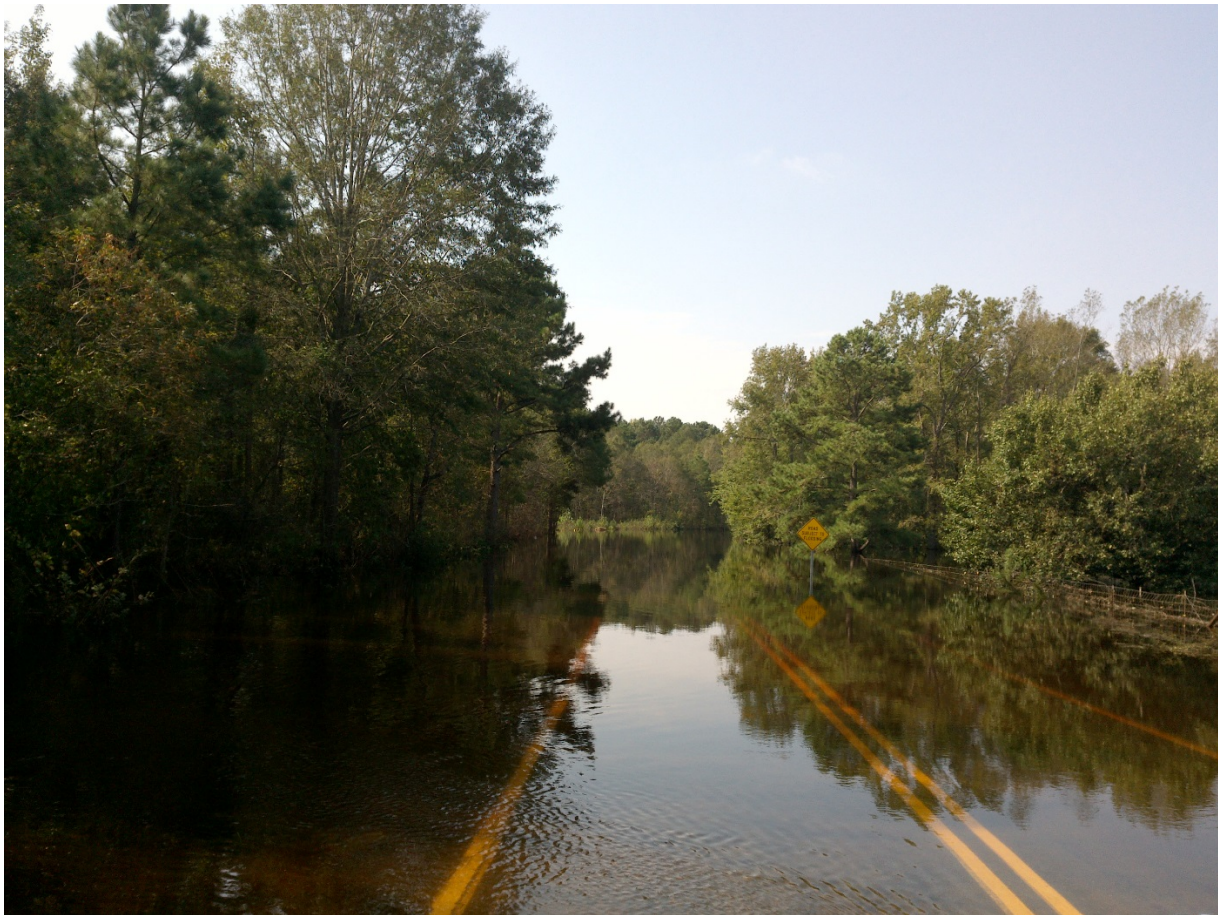
Ferry Bridge Road leading into inactive coal ash basin complex.

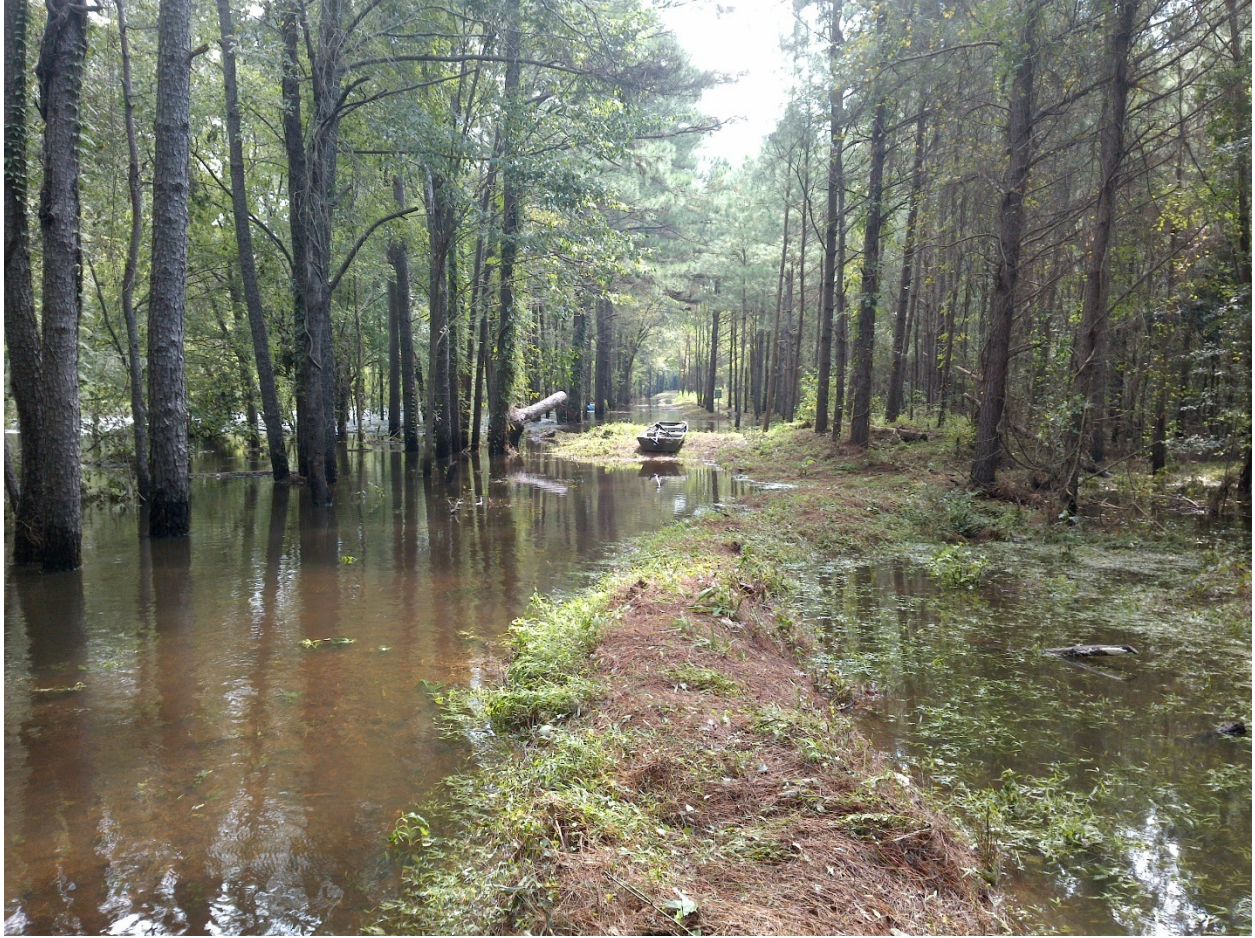
Interior of inactive ash basin complex.

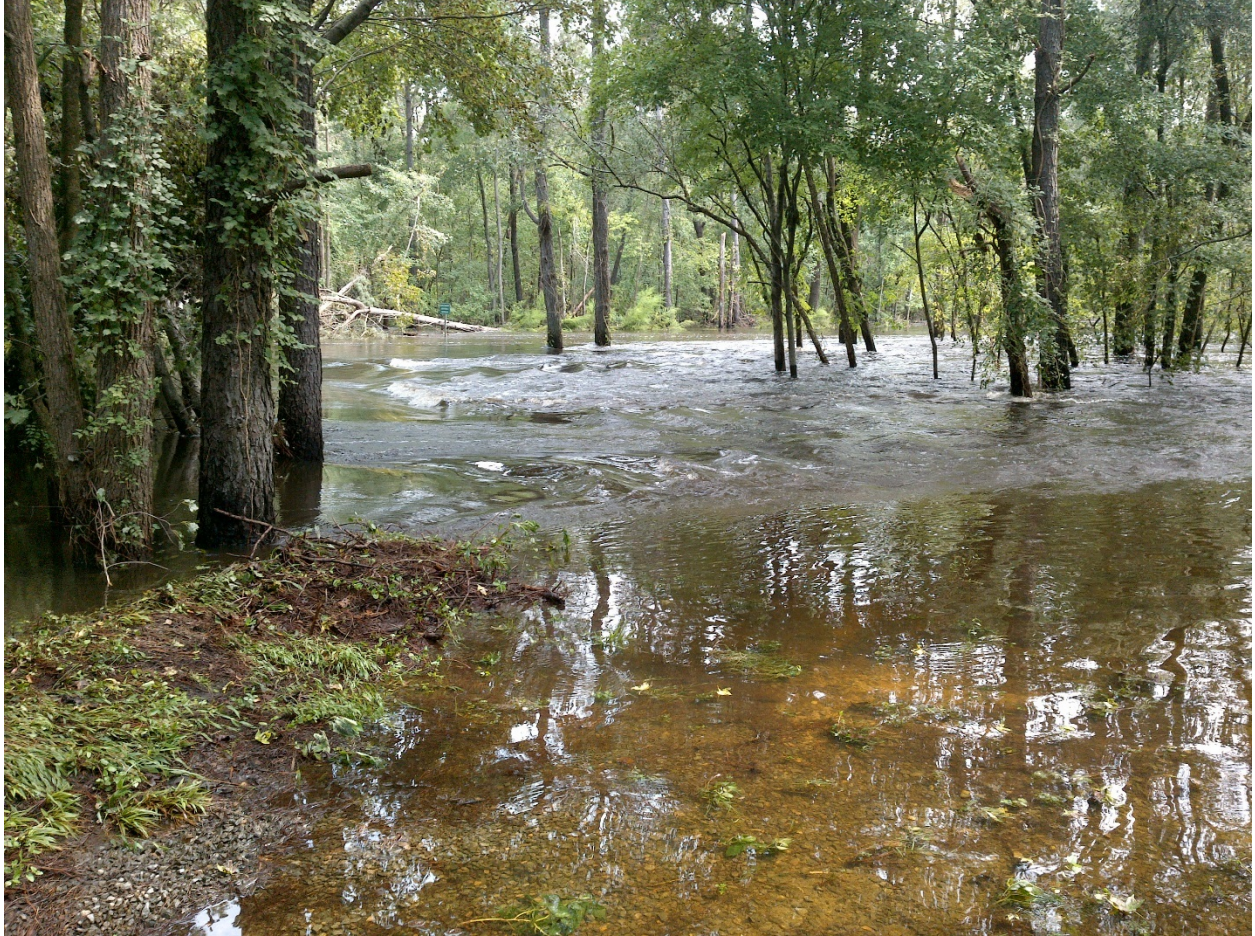
Halfmile Branch flowing through Inactive Ash Basin Complex.

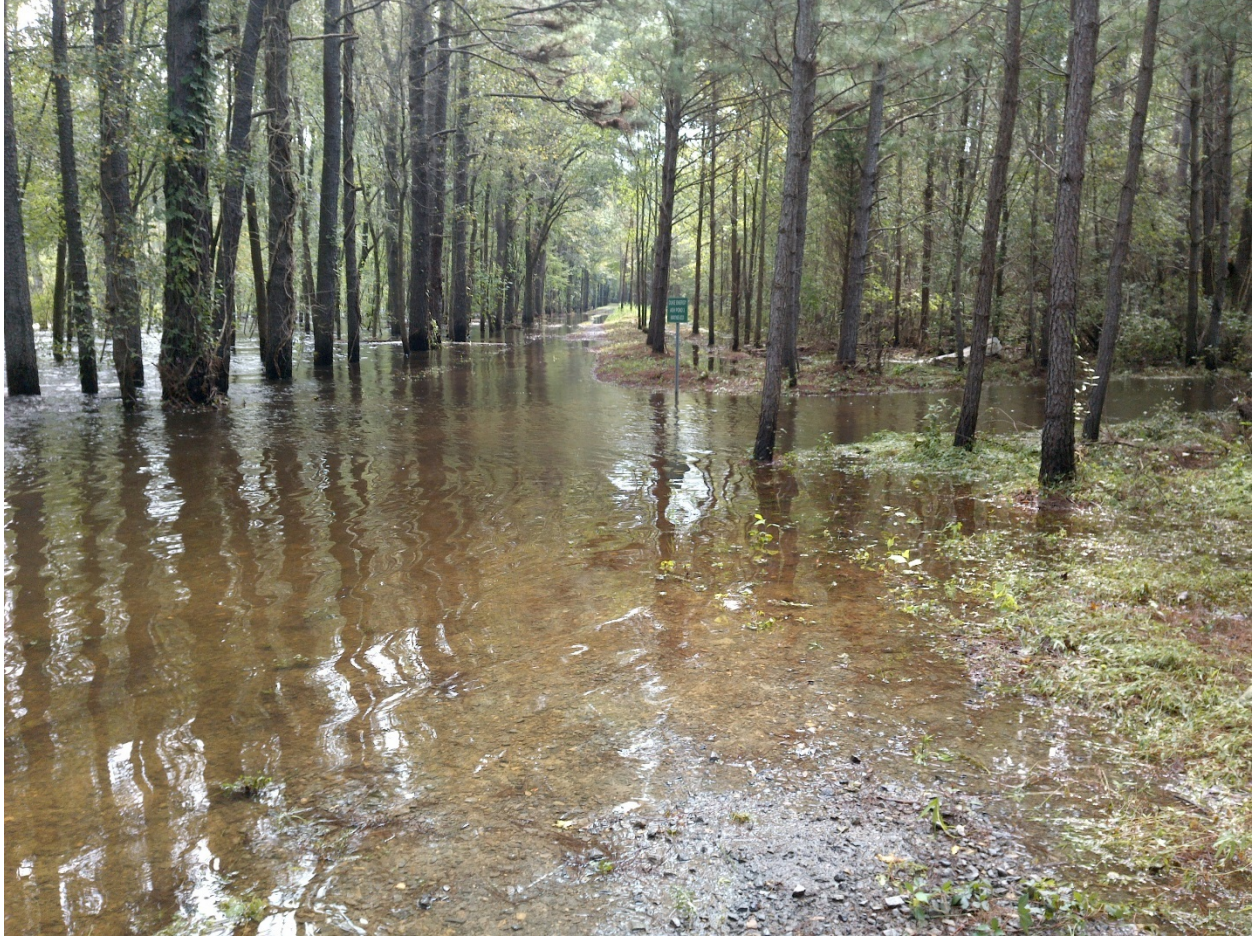
Conditions along access roads throughout inactive ash basin complex.

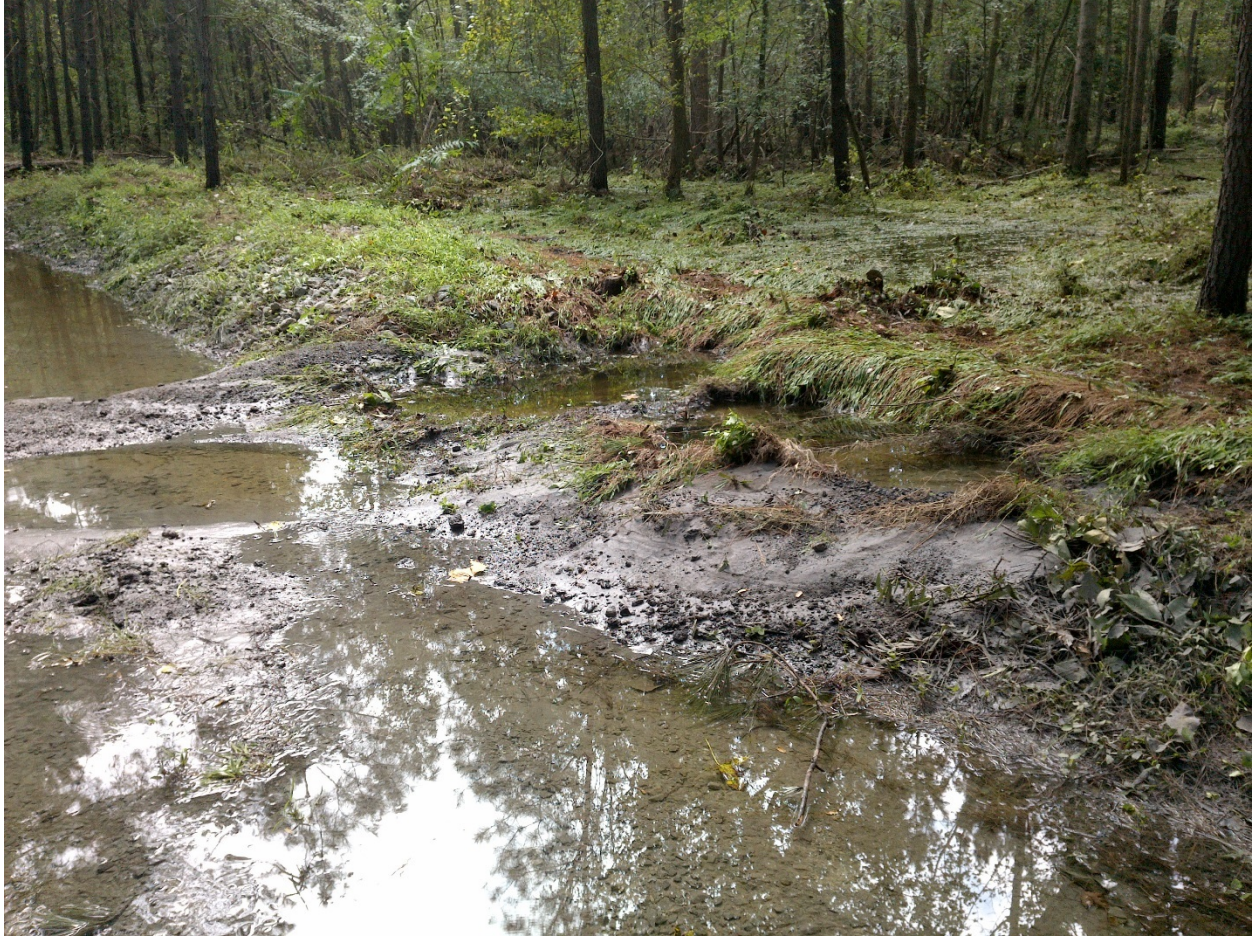
Area where some volume of ash sloughed off, washed over, and resettled outside of original as boundary.

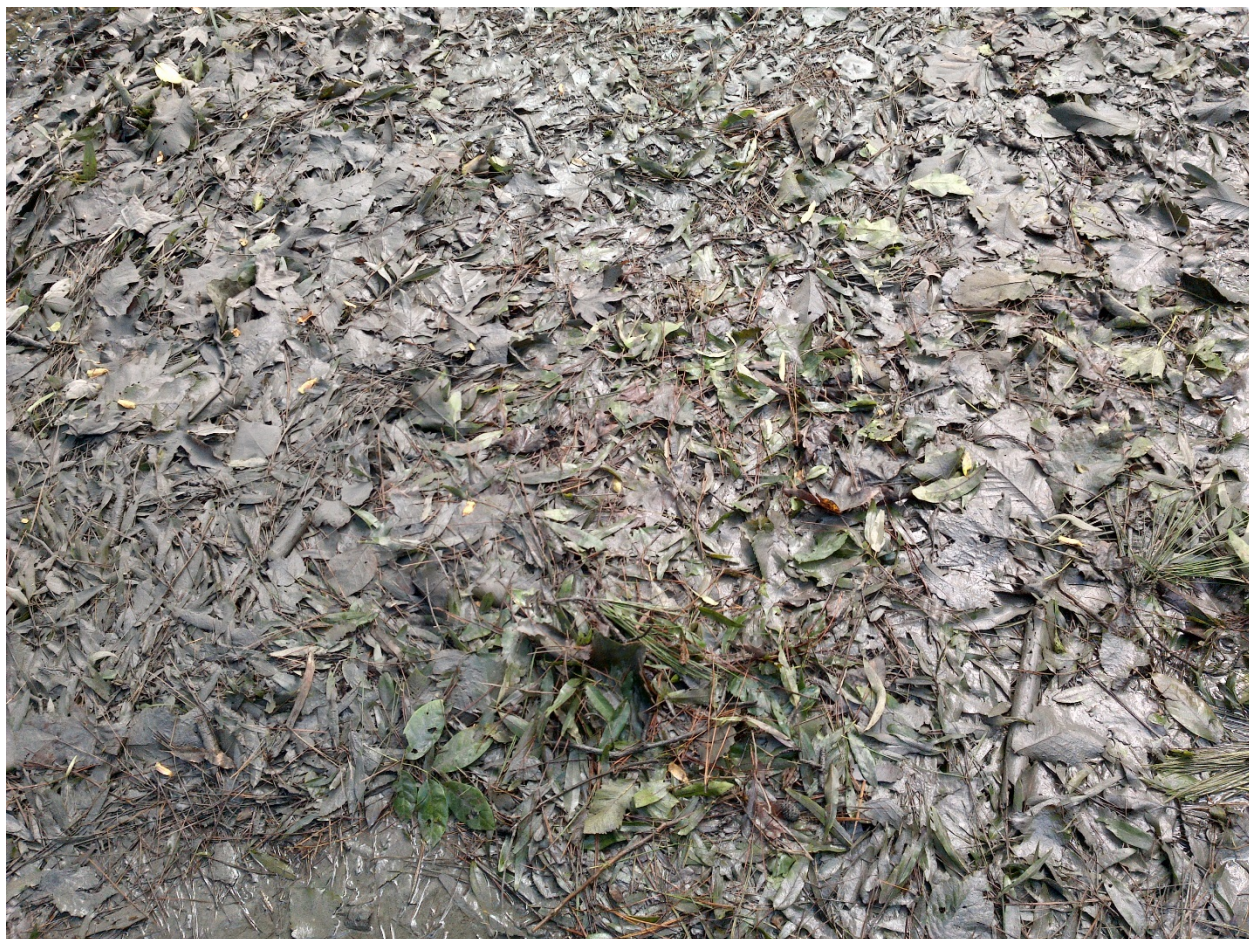
Settled ash redeposited in vicinity of original wash/sloughing.

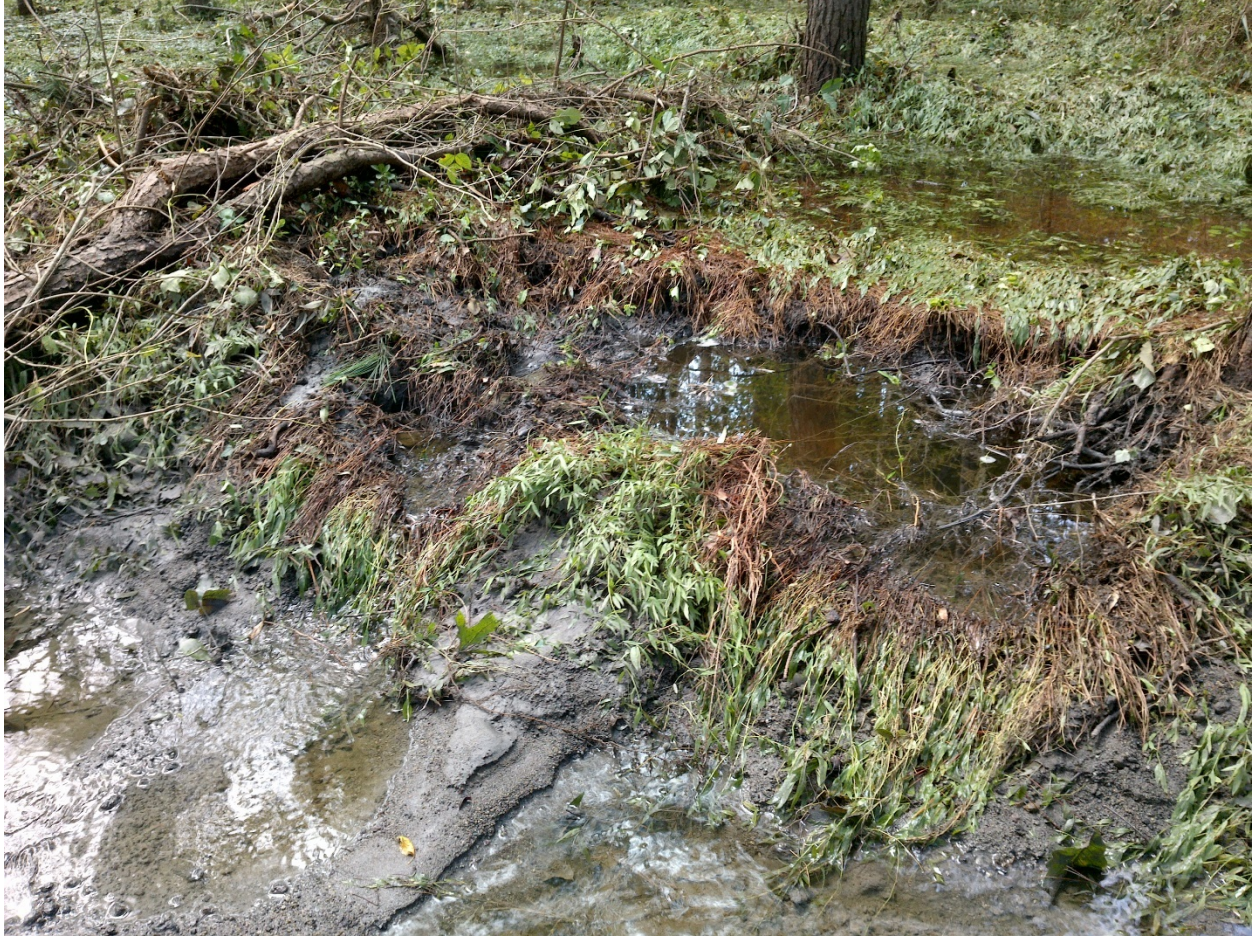
Area of washed coal ash/sediment.

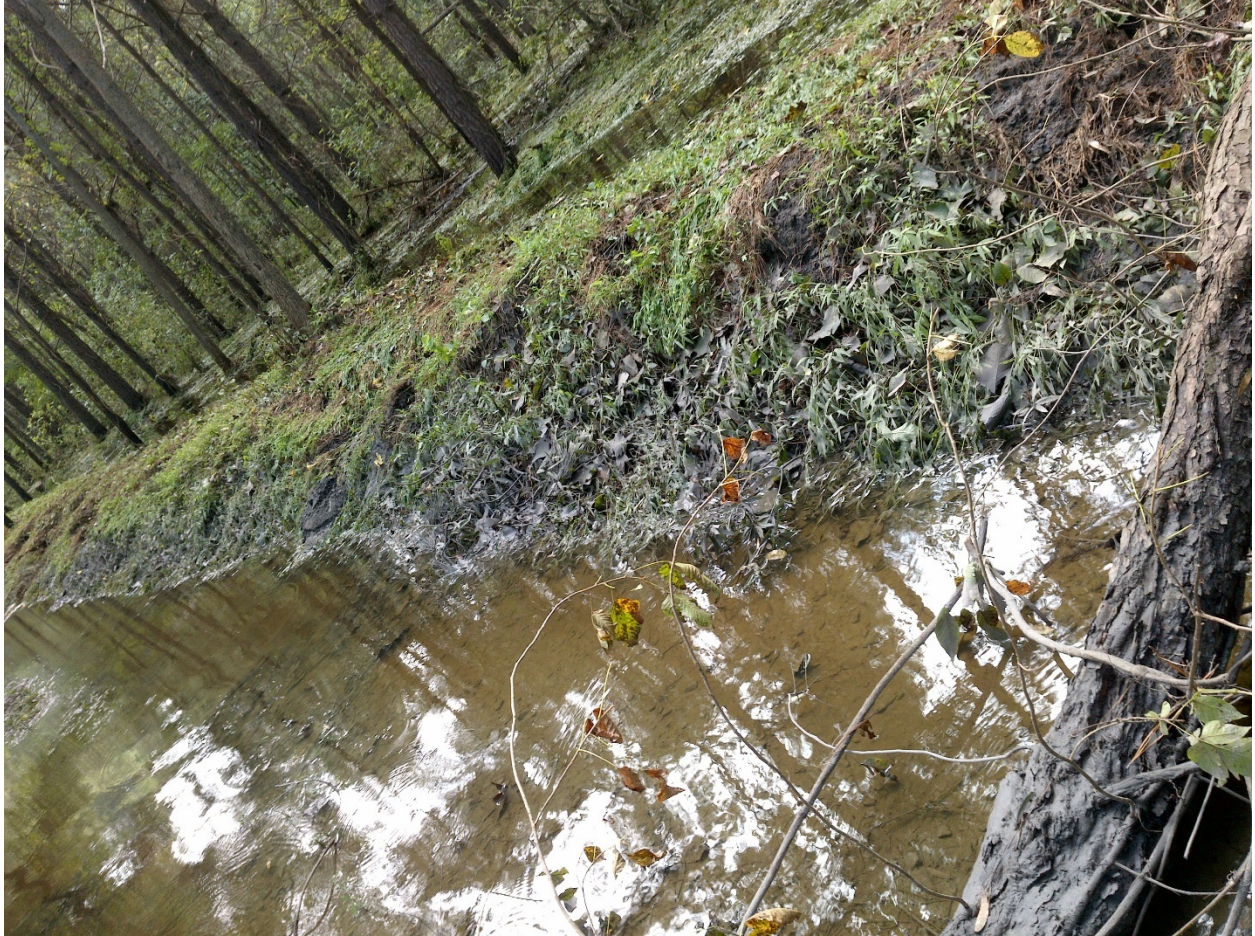
Flooded ash basin complex behind dike wall boundary. Some silting/ash along outside of ash basin dike wall.

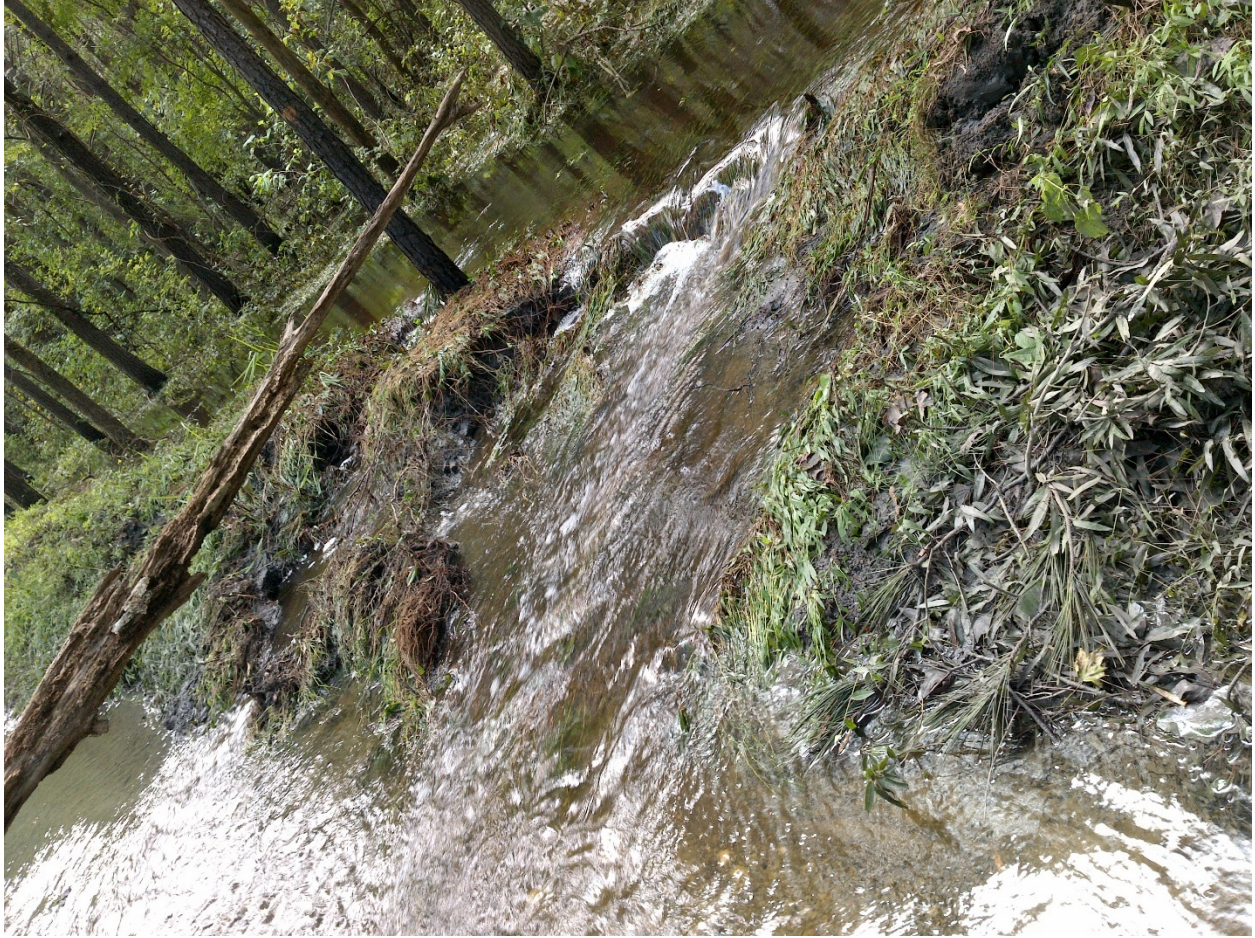
Flowing floodwaters exiting ash basin across basin dike wall.

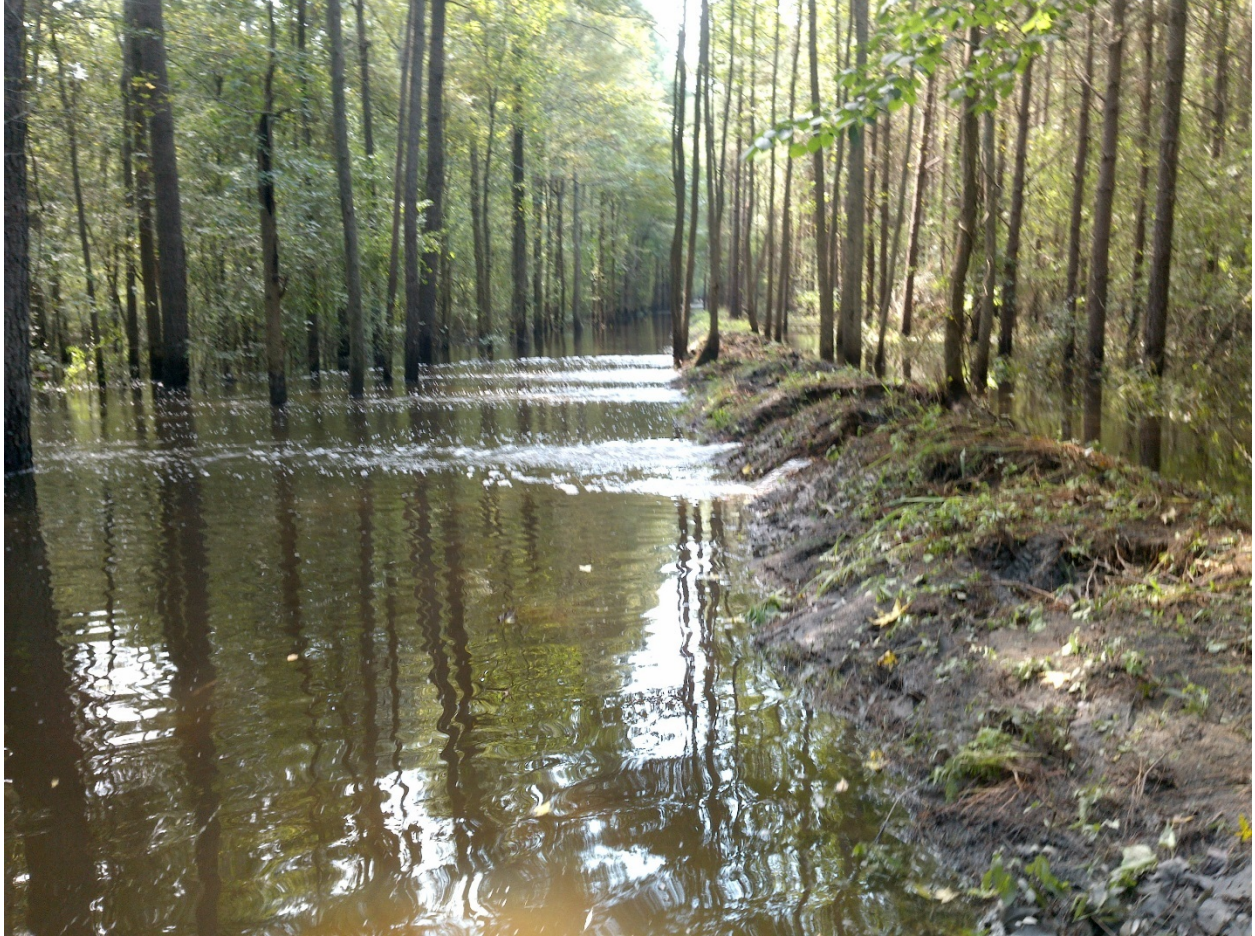
Flooded ash basin complex. Water flowing from ash basin, across/through dike, across access road to Halfmile Branch.

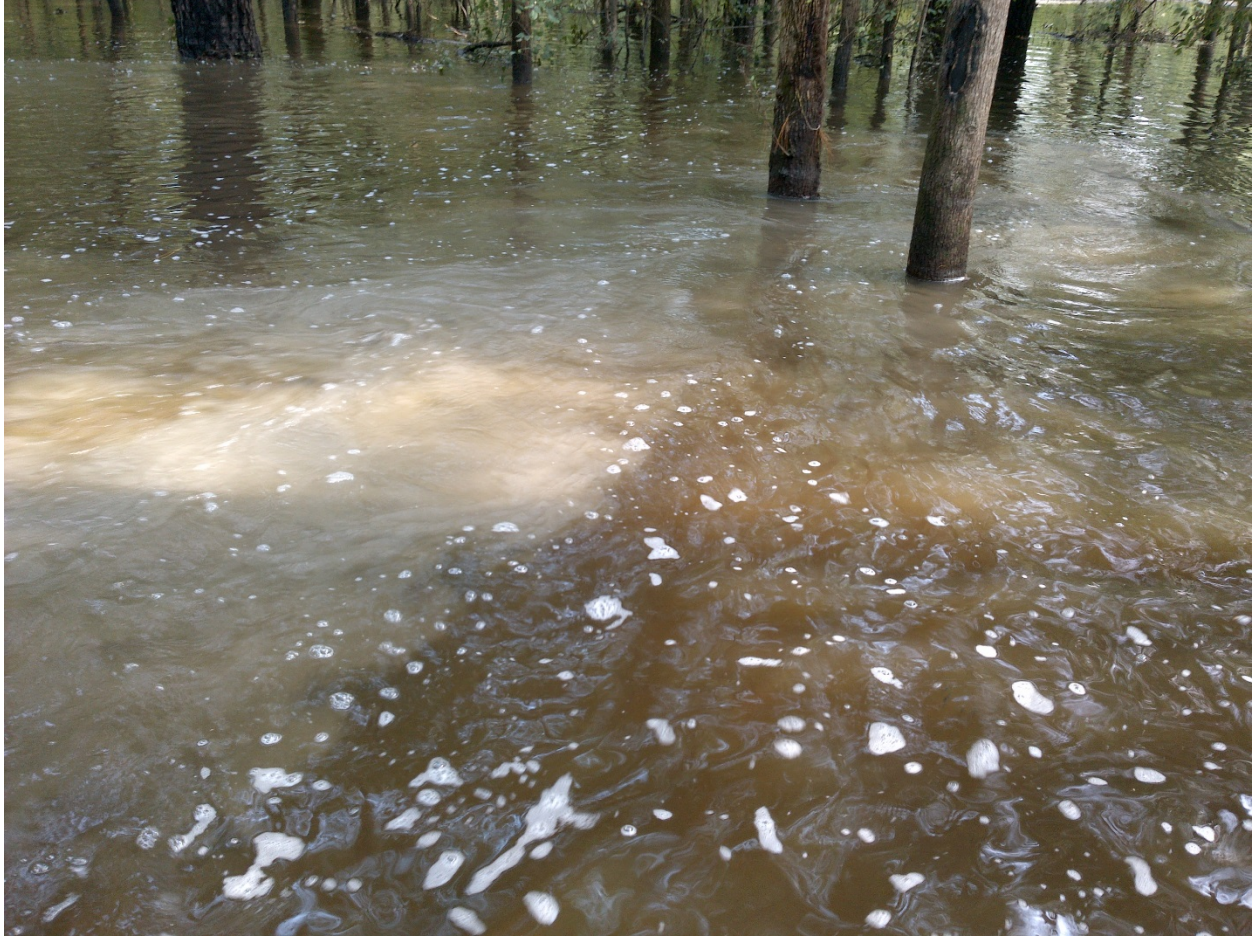
Potential ash/sediment cloud in floodwaters.

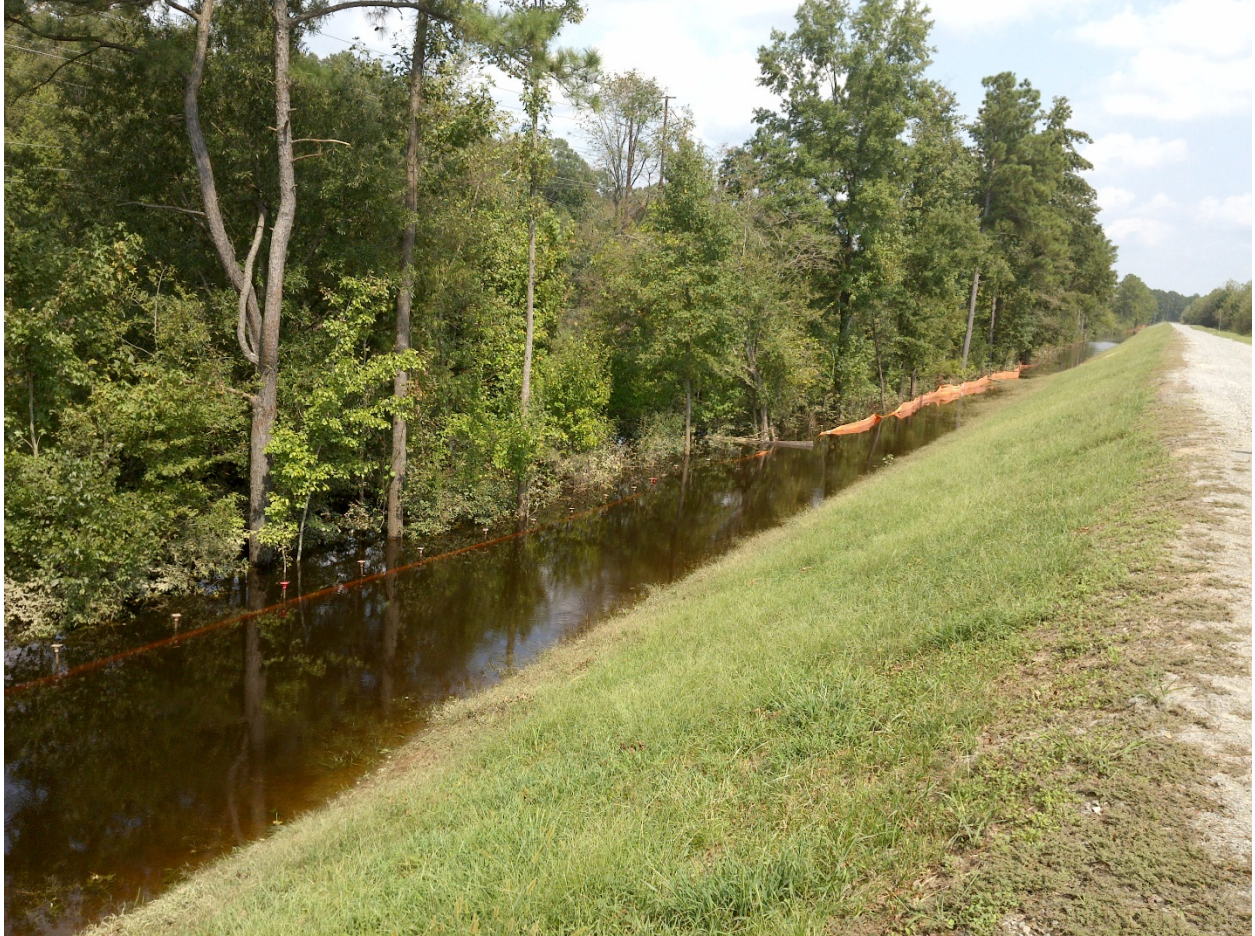
Neuse River floodwaters encroaching on active ash basin dike wall.

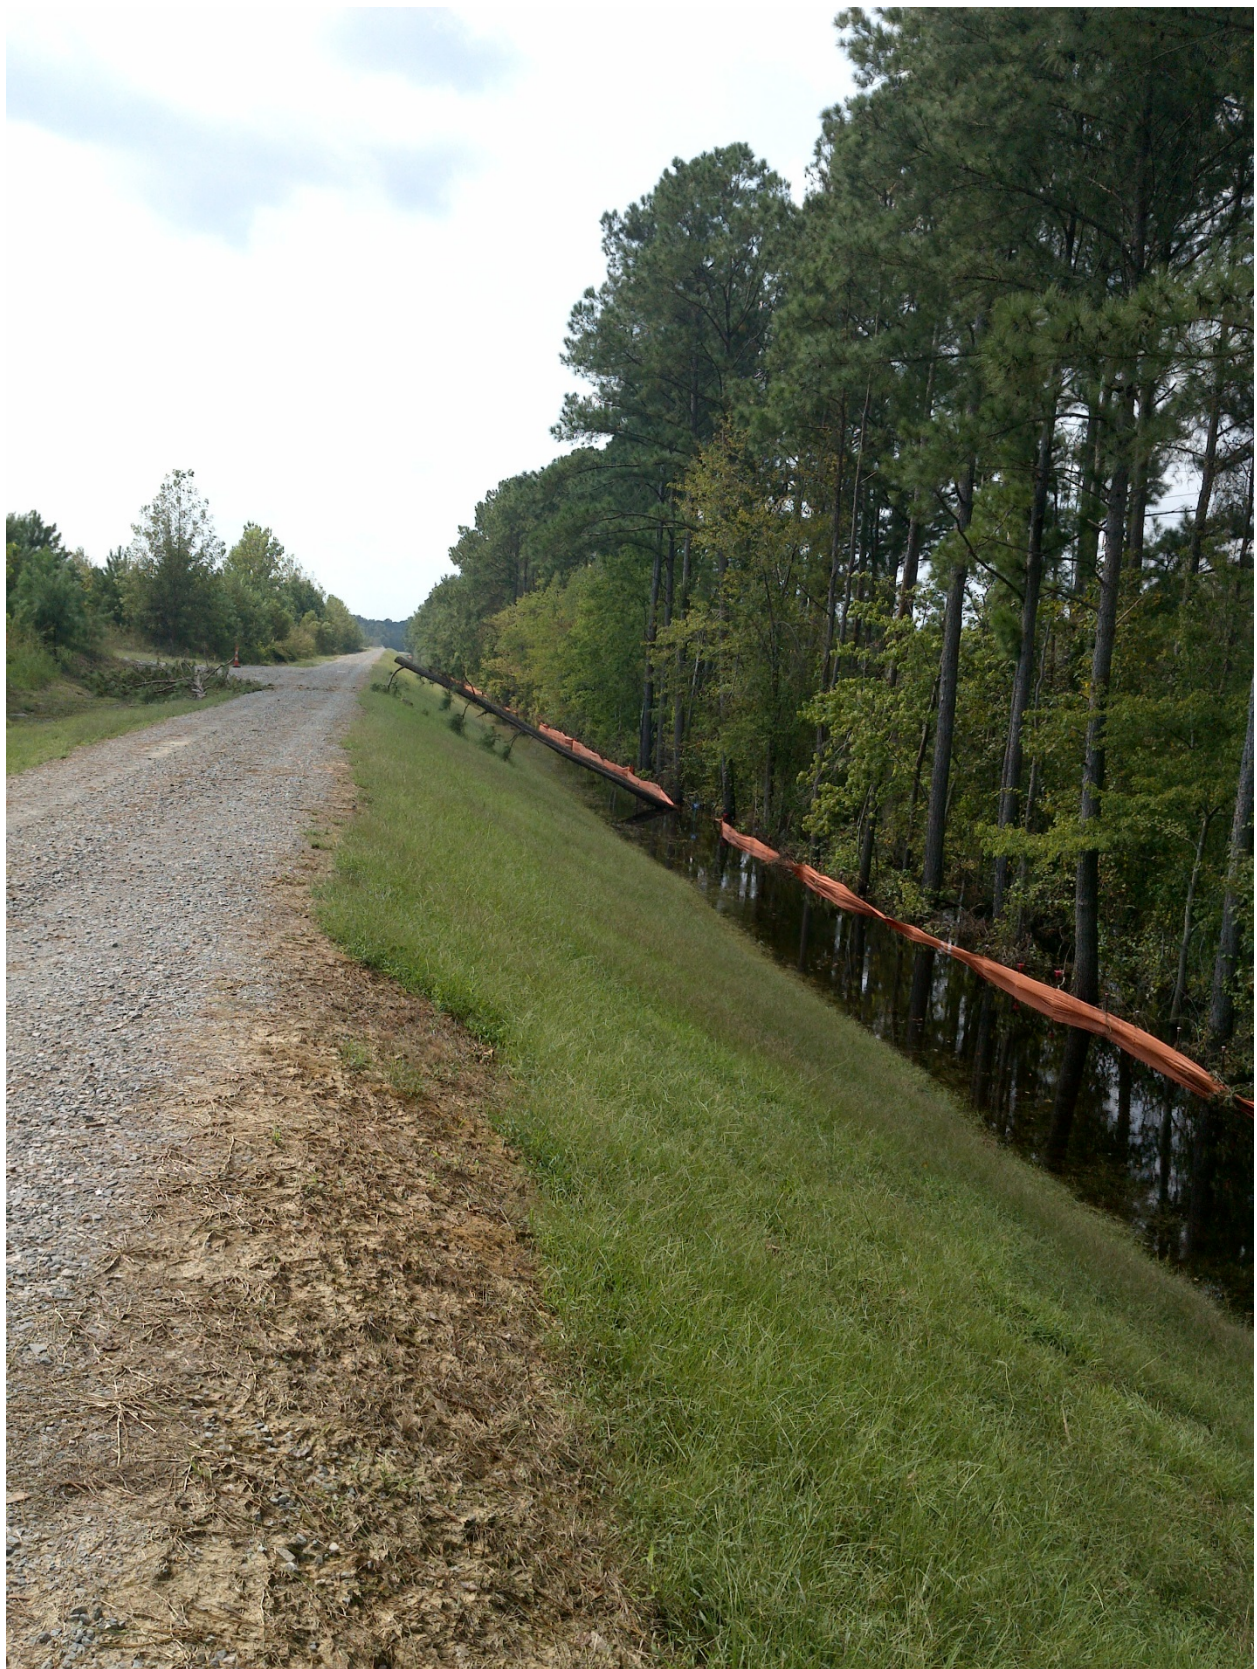
Neuse River floodwaters encroaching on active ash basin dike wall.

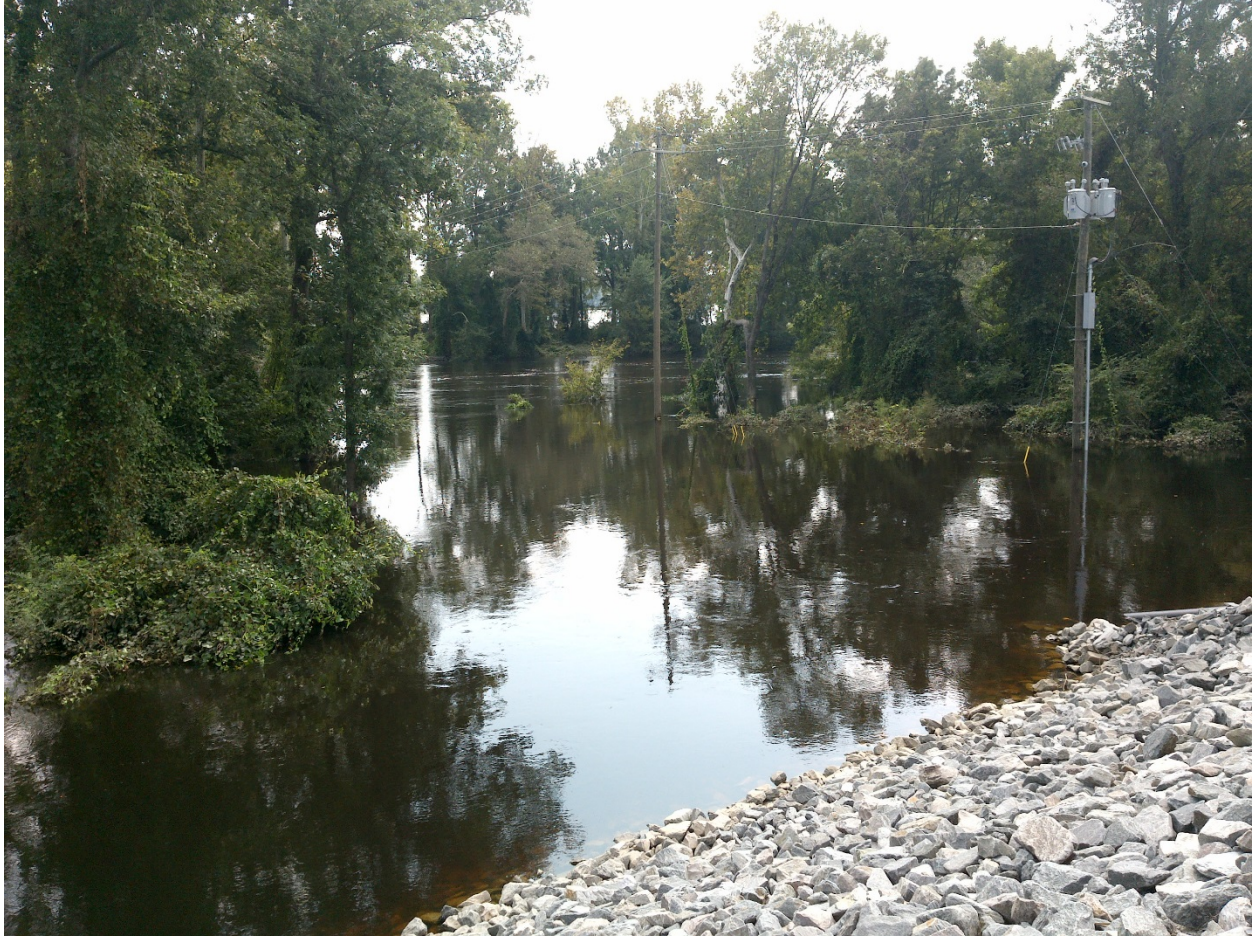
Area of Active Ash Basin outfall, submerged under Neuse River floodwaters.

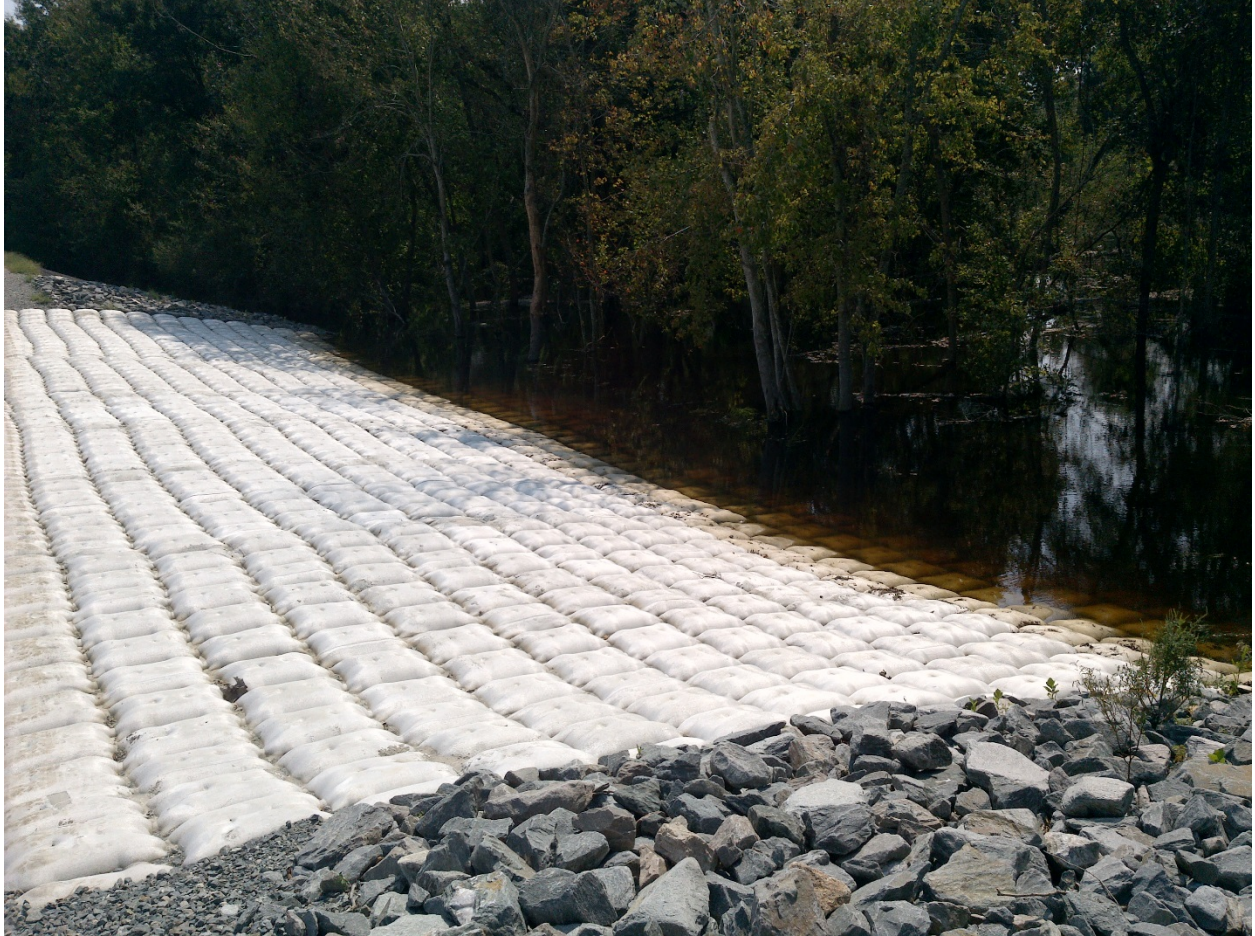
Floodwaters encroaching on outside cooling pond dike wall at newly constructed emergency spillway.

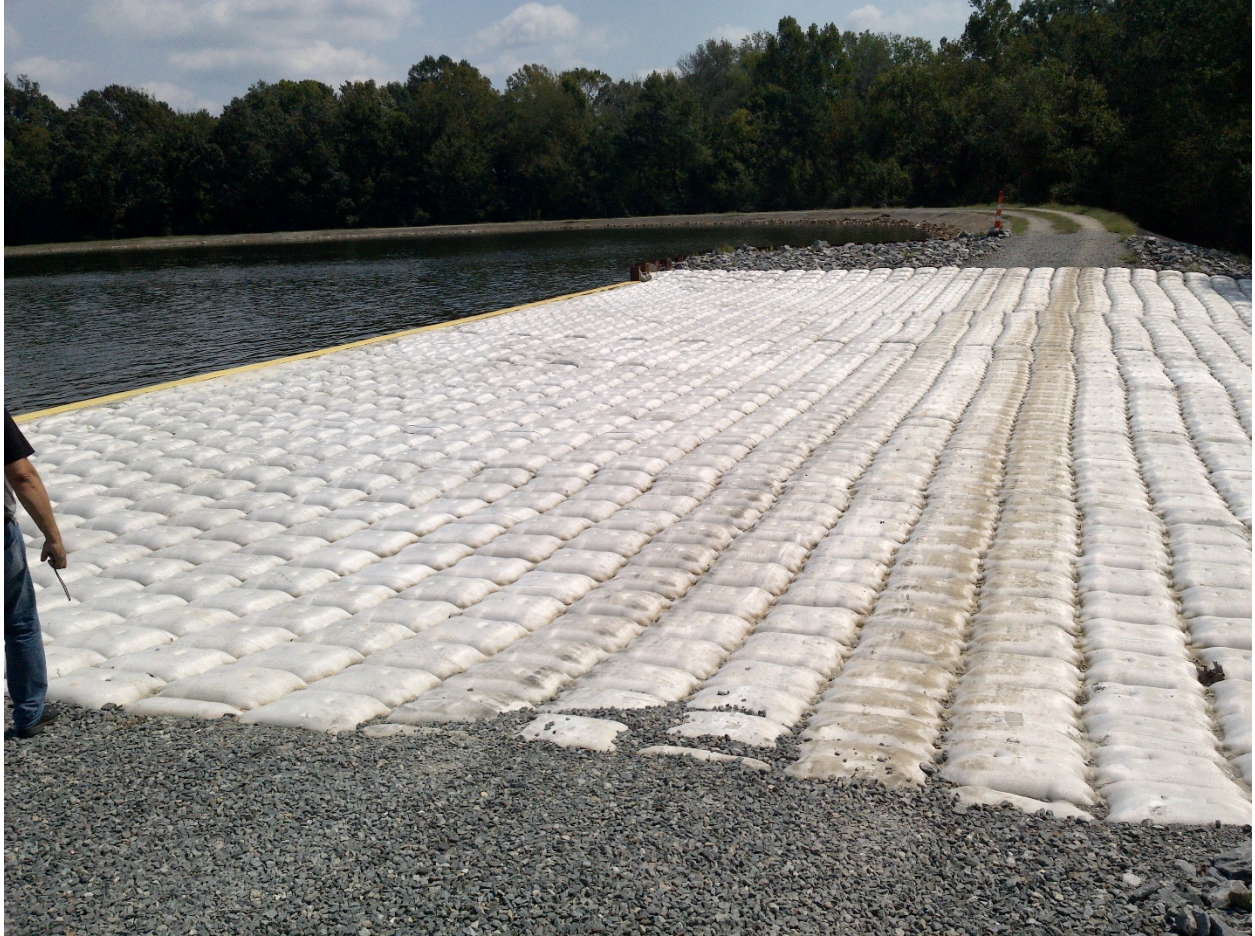
Newly constructed cooling pond emergency spillway.
